# D785N

## CMS CSC DDU VERSION 4

TITLE  
 OPTICAL TRANSCEIVERS AND ROCKET I/O  
 FULL DDU  
 CMS CSC ELECTRONICS

OUTPUT CONTROL  
Practice Full DDU  
CMS CSC ELECTRONICS

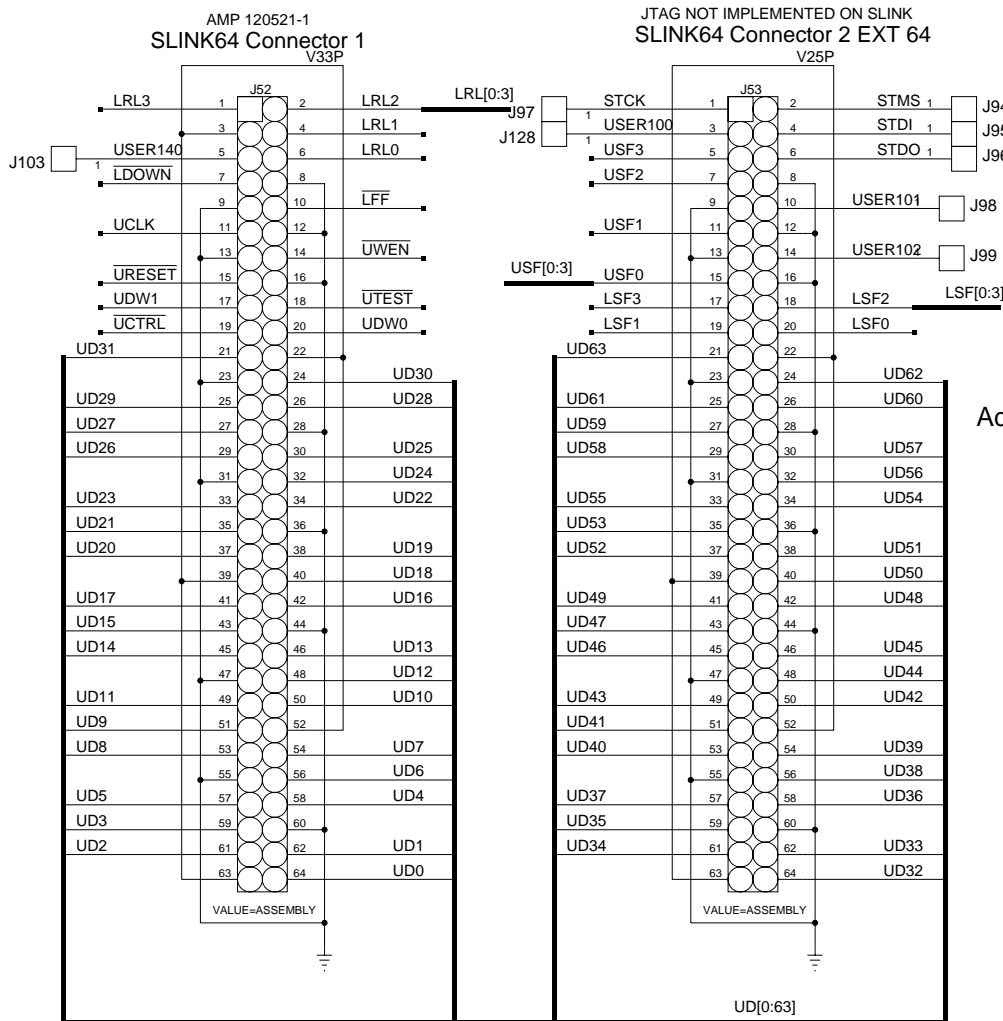
Not Used on Current LSC  
UDW[0:1] = 11 FOR 64 BIT TRANSFERS

SLINK64/LSC Standoff Holes  
Isolated per SLINK Spec pg. 43/62

Voltage Keying Hole

USER140, USER101, USER102 NOT USED  
USER100 IS FOR DESKEW OPTION, NEED TO DRIVE

Add accessible testpoints for UCLK, UWEN, UCTRL very near S-LINK port

fix 3.3v 2.5v on slink
